Report Number: SHFT260200009771

Sample name: i-Bracket

Test Method: Refer to Appendix E of QB/T 2761-2024 to test the spatial removal efficiency of microorganisms at 0.5h, 1h, 1.5h, and 2h and report the result of removal rate.

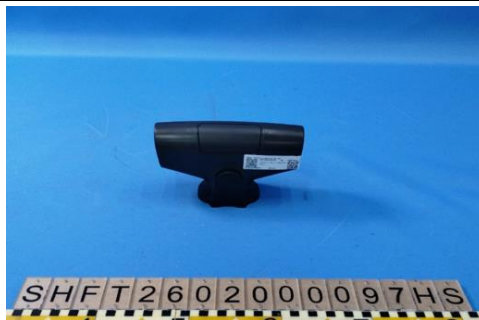
Sample photo

Description of Sample: Black purification equipment  
 Customer ID: N/A  
 SGS ID: SHFT2602000097HS M1  
 Test Microorganism: Mycobacterium abscessus ATCC 19977  
 Chamber size: 1m<sup>3</sup>
